Strawberry Run Forensic Investigation

Prepared for:
Stormwater Management Division Transportation and
Environmental Services

City of Alexandria

June 2022

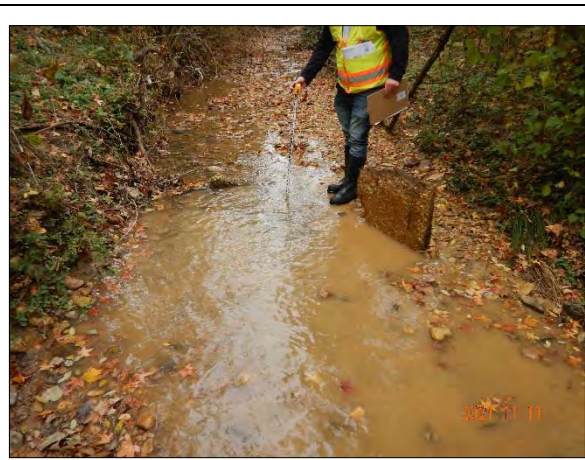
Figure 8. Cross-Vane #1 – Looking Upstream (November 2021, Station 2+40)

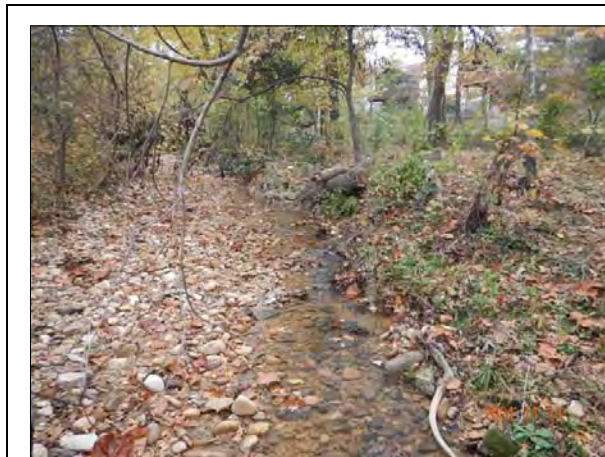
Figure 54. Cross Section 0+50 (B3/4c) Looking Upstream

Representative reaches were classified in accordance with Rosgen's Classification of Natural Rivers. The upstream section (4+90) is classified as a G stream type (narrow and deep), whereas the downstream sections are wider and classified as F and B stream types. The G stream type is narrow and deeply incised in depositional material primarily comprised of an unconsolidated, heterogeneous mixture of gravel, some small cobble, and sand. The F stream type is entrenched, wide, meandering channel, deeply incised in gentle terrain. The B stream type is typical of moderate to gently sloped, narrow valley, moderately entrenched, and generally low streambank erosion rates.¹⁰ For the Rosgen classification, the number next to the letter represents the dominant bed material (1= bedrock, 2 = boulders, 3 = cobble, 4= gravel, 5 = sand, and 6 = silt/clay). For example, Cross Section 4+00 is an F stream type consisting of approximately equal parts gravel and cobble (F3/4). The lowercase letter next to the number representing dominant bed material indicates classification between stream types based on slope ranges. For example, Cross Section 0+50 is denoted as a B3/4c because the slope is less than 2%. Stream classification variables are summarized in Table 3.

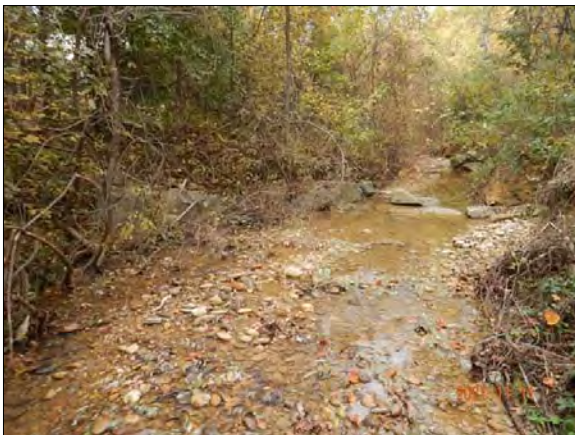
Figure 58. Cross Section 4+00 (F3/4) Looking Upstream

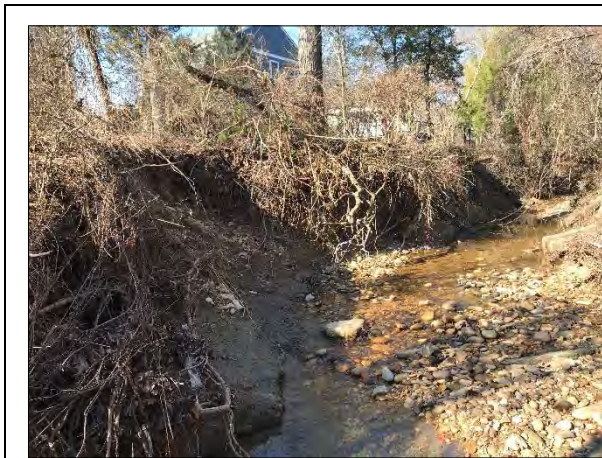
Figure 74. Upstream Sediment Supply

1. Upstream bedload supply (Figure 74). Ideally restoration of the upstream section should have been conducted before restoring the downstream reach. Excess sediment in the channel contributes to aggradation and lateral channel instability and widening.

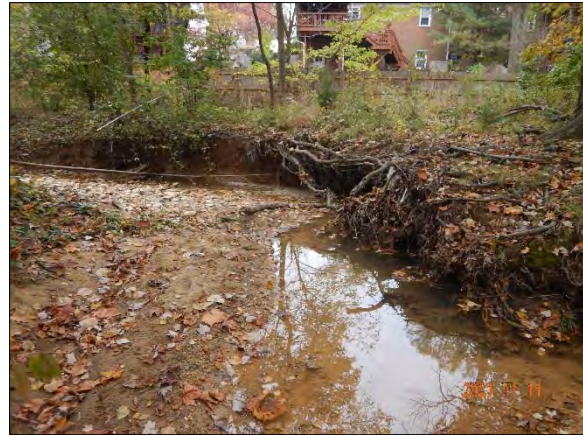
3. Downed trees/channel blockages (Figures 76 and 78). Like excess sediment, channel blockages and debris have the potential to cause local flow accelerations and flow diversions leading to bank erosion and widening. While logs can be useful as bank protection measures, structures need to be securely anchored and placed to prevent washout (Figures 77 and 79).

Figure 77. Same Location: Tree Washed Away (November 2021, Station 1+90)
